Unpaved roads' surface evaluation using unmanned aerial vehicle and deep learning segmentation

A thesis
presented to Lakehead University
in fulfillment of the
thesis requirement of the degree of
Master of Science

Thunder Bay, Ontario, Canada, 2021

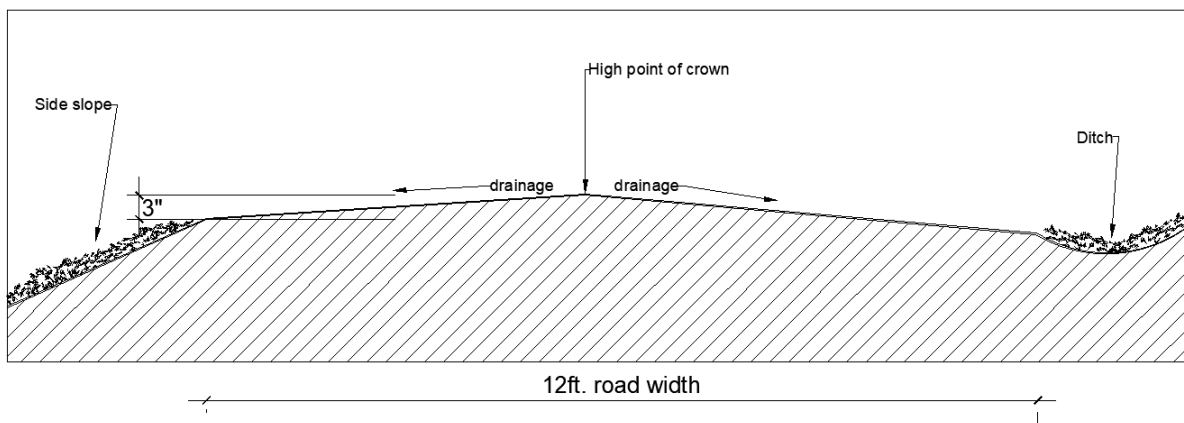
Figure 3: Crown profile: $\frac{1}{2}$ " of crown per foot of road width (e.g., $\frac{1}{2}$ " x $\frac{1}{2}$ x 12' road = 3" crown)

A primordial reason to build a crown into the roadway is to drain water off the roadway quickly. According to MDEP (Maine Department of Environmental Protection 2016), a road crown could be smoothing or super-elevating of the gravel road. The crown can also be defined as building a high point that runs lengthwise along the center of the road so that either side of this high point is sloped gently away from the center toward the outer edges of the road, as presented in Figure 3.

Usually, a gravel road should have a 1/2 inch or 3/4-inch slope per foot of the road width. The MDEP (Maine Department of Environmental Protection 2016) recommends that the crown maintenance must be done annually, because the weather wear and traffic load could deteriorate this mild slop.

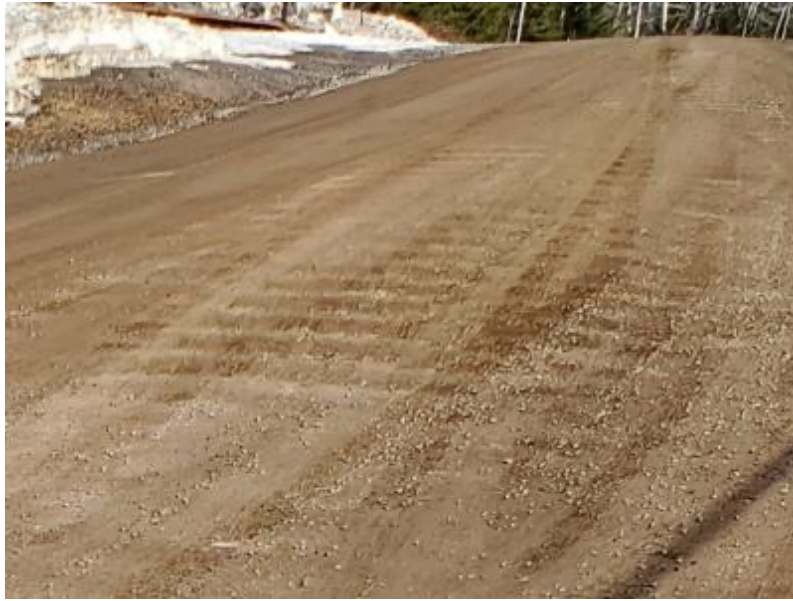
Figure 5: Washboarding (corrugation) of an unpaved road surface

Washboarding, also known as corrugation, is a series of spaced ridges and valleys that are perpendicular to the longitudinal axis of the road and usually have rather similar intervals (Eaton et al. 1989), as presented in Figure 5. It was mentioned that washboarding can be caused by traffic load action and loose aggregates (Eaton et al. 1989; Walker 1991).

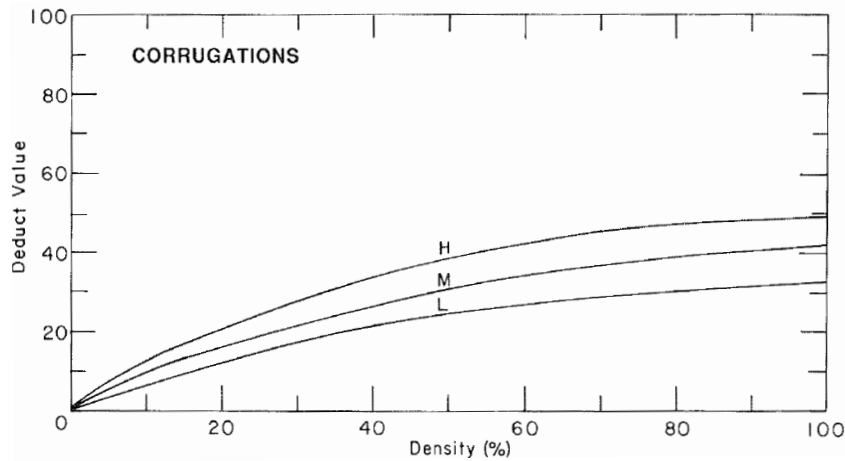
Figure 6: Deduct-value curves for corrugations (Eaton et al. 1989)

The severity level L (low) means that the corrugation (washboarding) depth is less than one inch, and the severity level M (Medium) indicates depths ranging from one to three inches. Finally, the corrugations deeper than three inches are classified as H (High) (Eaton et al. 1989). This classification is based on the PAVER PMS Method, which was developed by the U.S. Army Corps of Engineers and the American Public Work Association. It is possible to classify this type of distress using the concept of Deduct-value, which is presented in Figure 6.

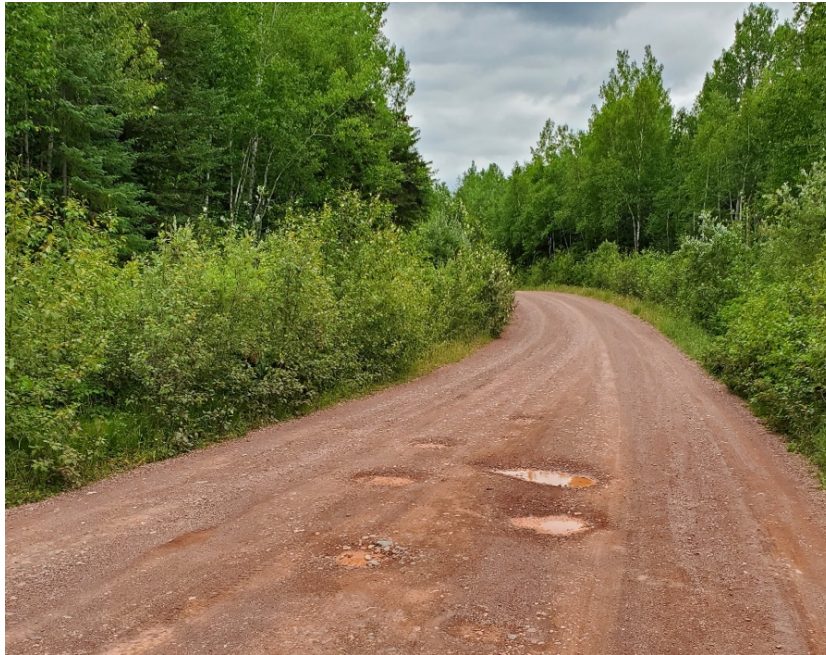
Figure 7: Potholes on an unpaved road surface

Potholes are localized depressions on the road surface. They typically have a diameter less than 3 ft, as shown in Figure 7. The MDEP (Maine Department of Environmental Protection 2016) identifies poor drainage of the road surface and insufficient road crown as the main causes of potholes on the road surface. Eaton (Eaton et al. 1989) stated that the potholes occur when traffic abrades small pieces of the road, and they grow as the water gets trapped inside them.

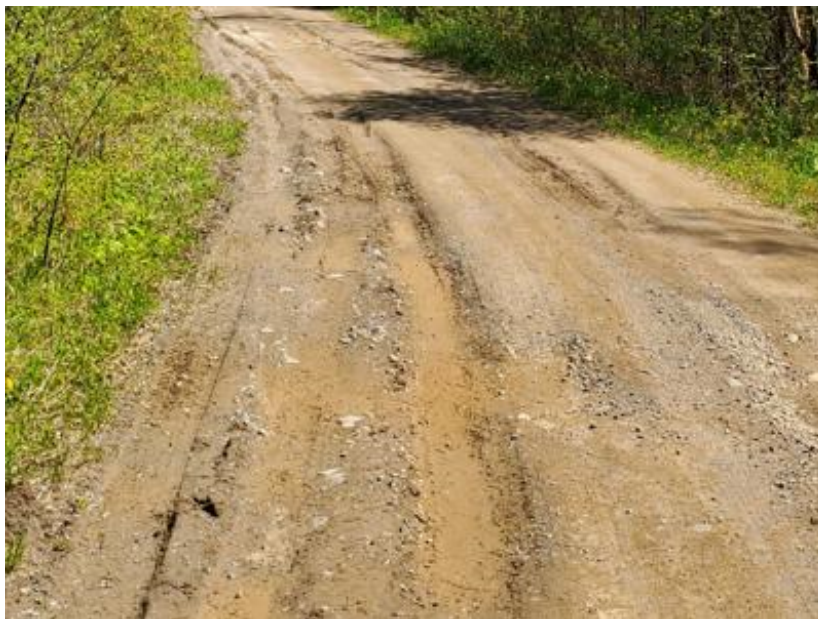
Figure 8: Rutting on an unpaved road surface

Rutting are long depressions that occur on the road surface parallel to the road's longitudinal axis (in the wheel path) (Eaton et al. 1989), as shown in Figure 8. Rutting can be an indicator of heavy traffic volume in the area (Eaton et al. 1989). According to Walker (Walker 1991), a rutting deeper than 3 inches can indicate a lack of sufficient gravel thickness. The MDEP (Maine Department of Environmental Protection 2016) goes further in explaining the possible reasons for rutting in the unpaved roads. Besides the high volume of traffic, ruts also expose a poor road base material, which prevents an efficient drainage, and insufficient ditching can also be pointed as one reason for rutting. All the cited reasons contribute to the softening of the road surfaces, and their combination with high traffic volume cause the rutting.

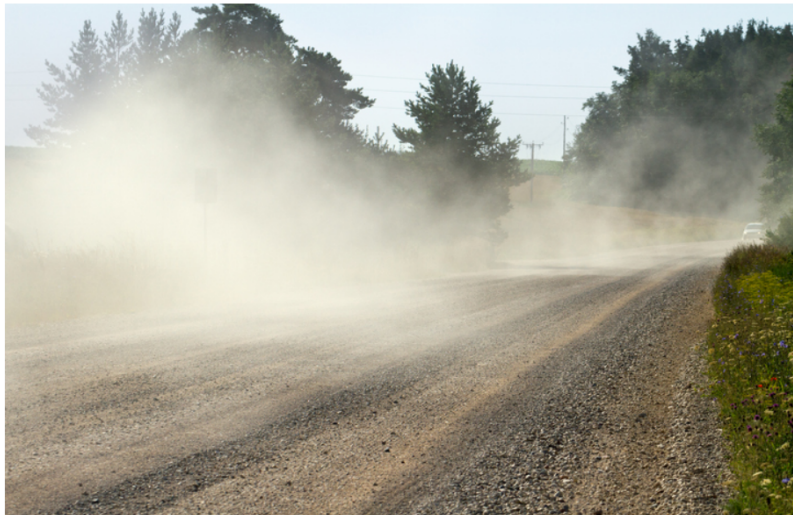
Figure 9: Dust on an unpaved road surface (From Oransi 2021)

Dust is a phenomenon that occurs due to the abrasive action of traffic on the unpaved road surfaces, as shown in Figure 9. Several conditions implicate in the dust defect, including gradation of the aggregate layer, traffic volume, and weather conditions. According to Walker (Walker 1991), dust can be a precedent to other severe defects, because it removes fines from the road surface. Dust can also cause safety issues as it can impair the drivers' vision.

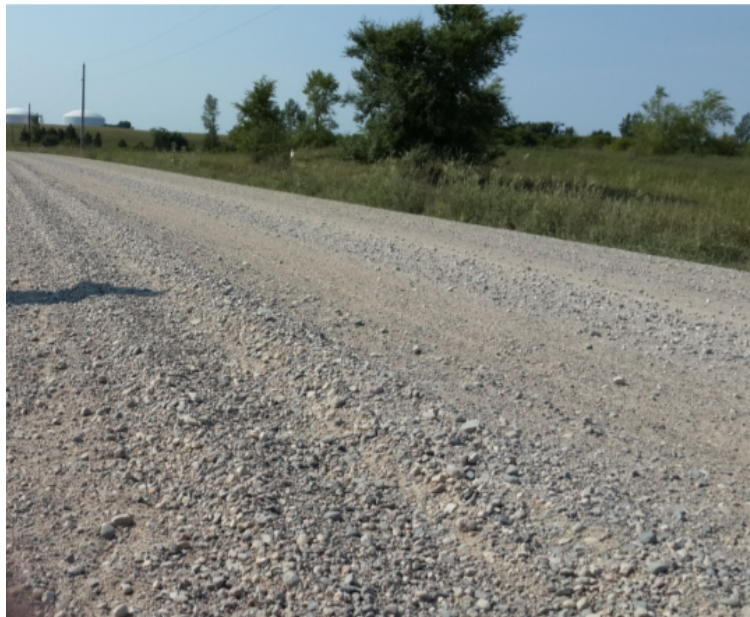
Figure 10: Loose aggregate on an unpaved road surface (From Jahren Charles 2015)

Loose aggregate occurs when the road's largest aggregate particles separate from the surface layer, which leads to the loosen base aggregates on the road surface. These loose aggregates can disrupt the traffic flow by collecting the particles between wheels paths. They can also negatively affect the road drainage ability. A sample road with loose aggregate is shown in Figure 10.

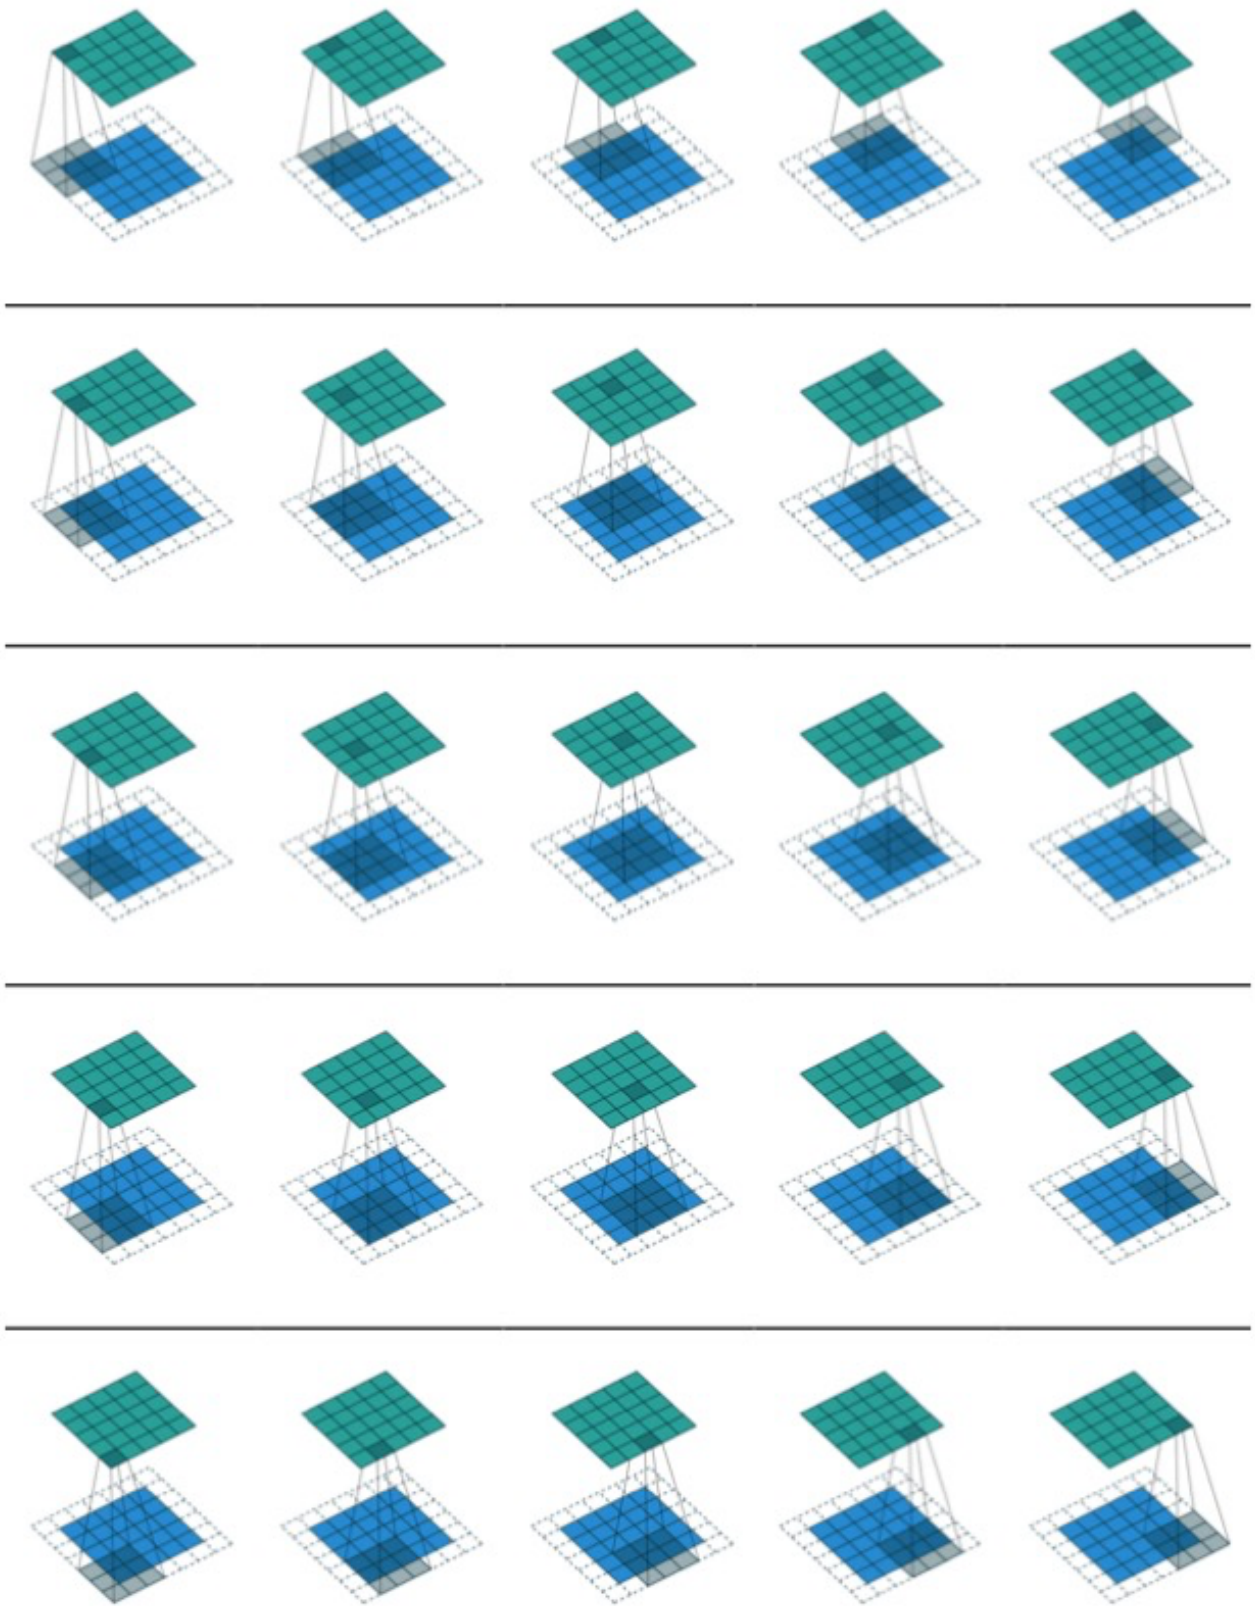
Figure 14: Representation of a convolutional operation (From DeepLizard 2019)

The convolution process consists of a filter applied to the regions of the input image, and this filter (kernel) can be represented by a matrix with a specific size, and it slides across the input image until it covers the whole image. The filter performs an operation in each position it passes through, which generates the output (DeepLizard 2019). This process is represented in Figure 14.

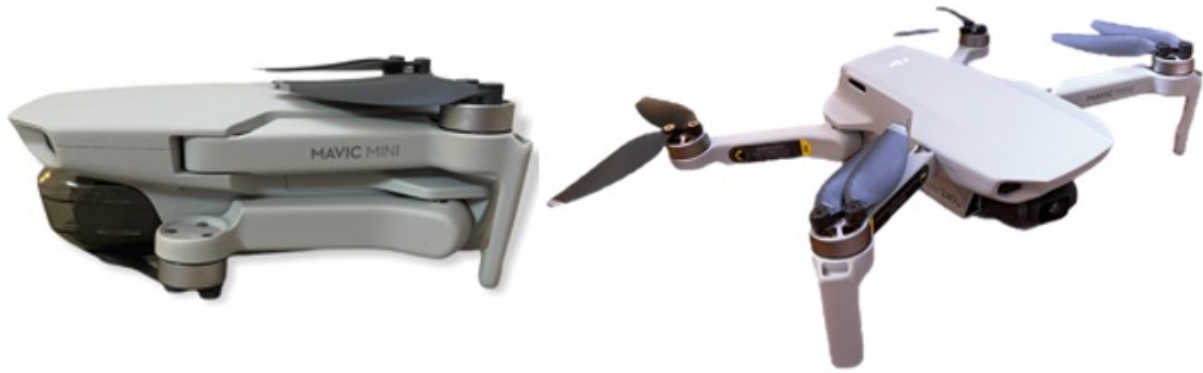
Figure 17: Mavic Mini Aircraft

The videos from the roads were captured using a micro-UAV, named Mavic Mini, which has a takeoff weight of 249g, with folded dimensions of 40×81×57 mm, and unfolded dimensions (with propellers) of 245×289×55 mm. This drone can fly up to 30 minutes with a fully charged battery. It has a built-in camera with 1/2.3" CMOS sensor and 12 MP resolution (Da-Jiang Innovations 2021). The Mavic Mini records videos in the MP4 format with up to 2.7k (2720×1530 pixels) resolution. The photos are captured in the JPEG format in two aspect ratios and sizes, including 4:3 with 4000×3000 pixels and 16:9 with 4000×2250 pixels. Figure 17 shows this UAV that can be controlled by a smartphone through its flight.

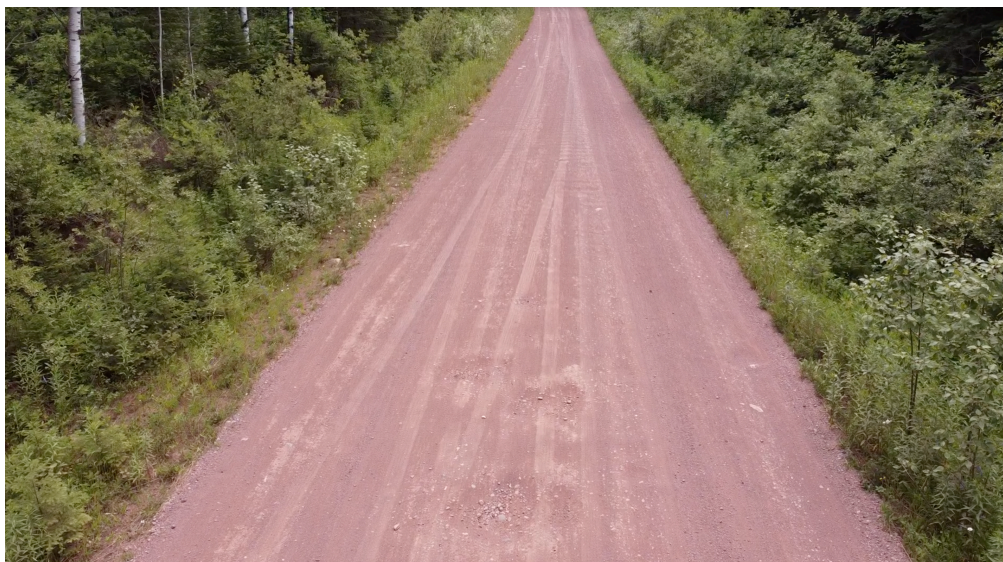
Figure 19: A sample captured frame

Figure 19 shows a sample frame extracted from the video captured using the proposed setup. A MATLAB code was developed to automate the process of frame extraction. This step is discussed in the next section (3.2).

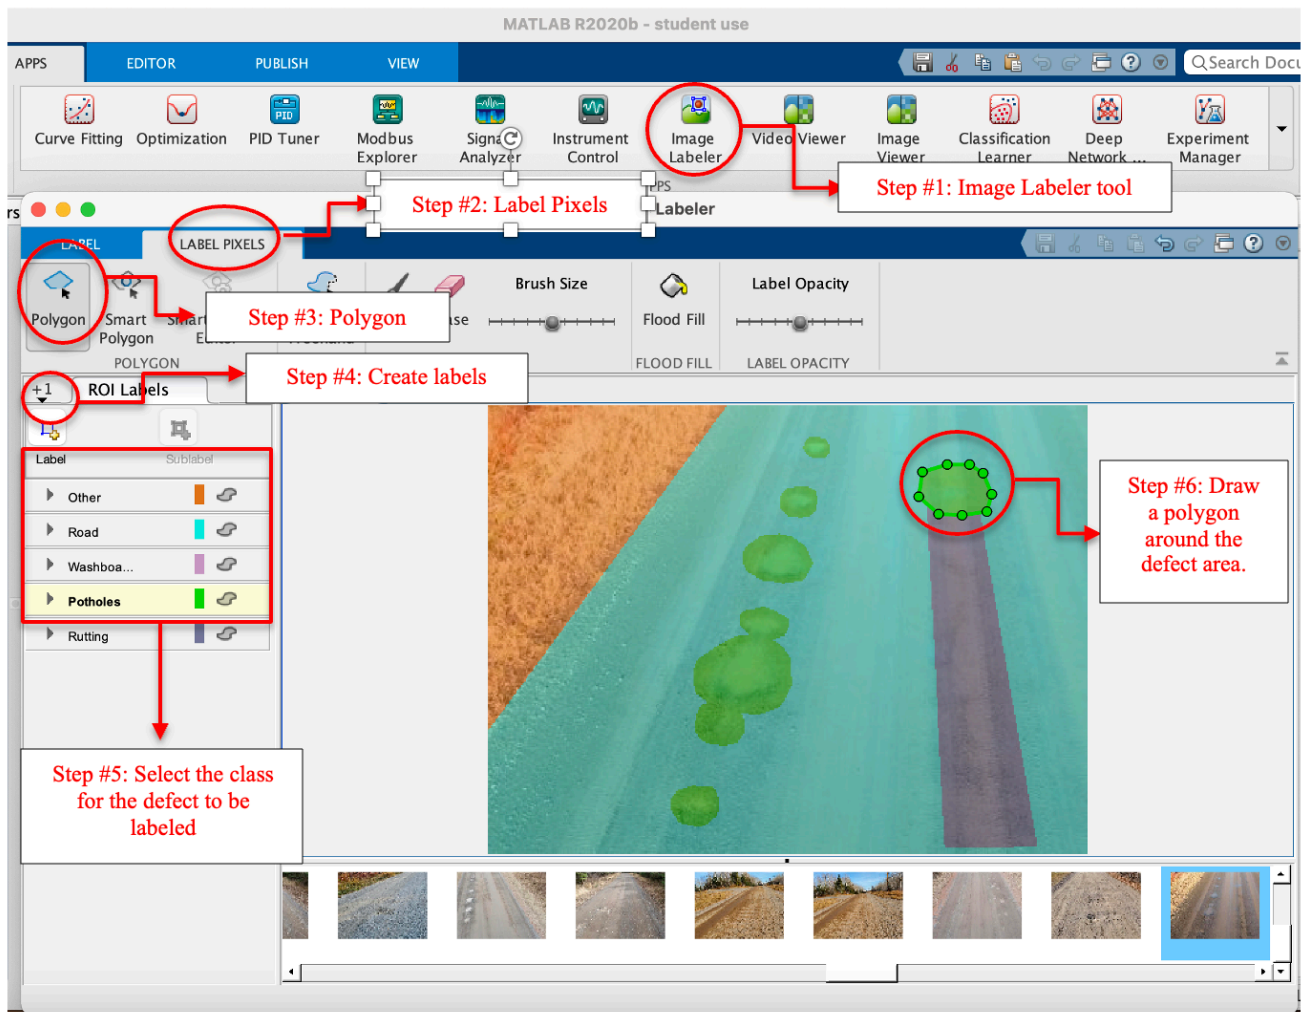
Figure 21: Image labelling process using Image Labeler tool of MATLAB® 2020b software

Since the supervised learning approach is used to train the DCNN classifiers, the training process requires a large number of labelled training samples. The labelling process consisted of manually labelling each prepared frame. All the training images were resized to 400 x 300 pixels. The size of training images might seem small, but this size was determined to create a balance between the massive required computational power and the available computing resources (e.g., GPU, CPU, and RAM). The labelling process was the least automated portion of this research because it required significant amount of human effort to label more than 1000 images. Most of the labelled images were used for training and the rest were used for the testing purpose. This step provided a base for the training process of the DCNN classifiers, as a solid training process is based on the variety of patterns and features available in the training samples, which can consequently enhance the performance of the classifiers. The labelling process was performed using the Image Labeler app available in the Computer Vision toolbox of MATLAB® 2020b software. The images were labelled on a pixel level using the polygon tool in the Image labeller App. Figure 21 depicts the steps taken to label images.

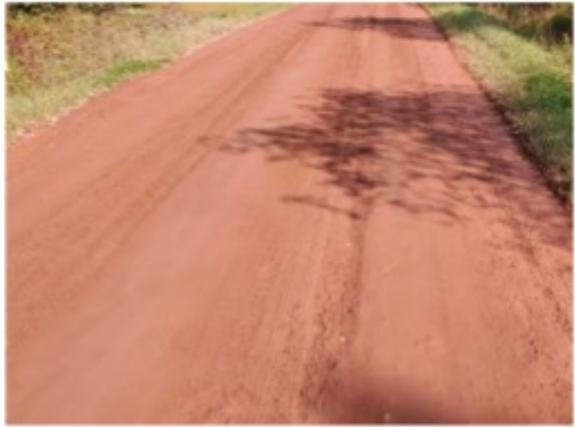
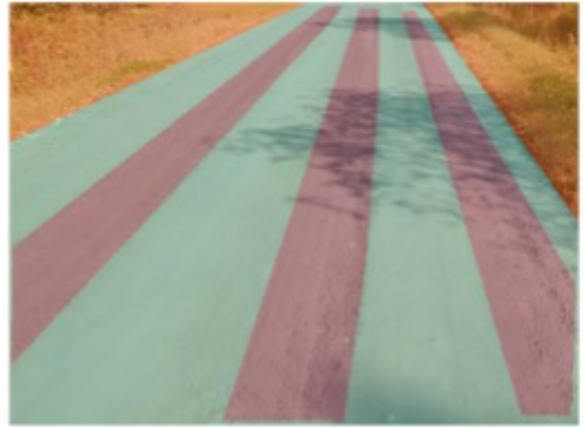
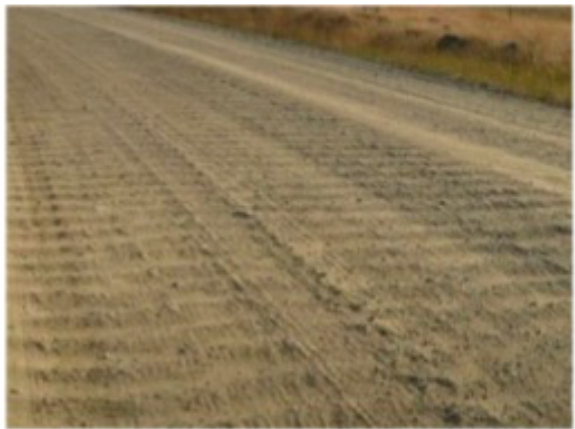
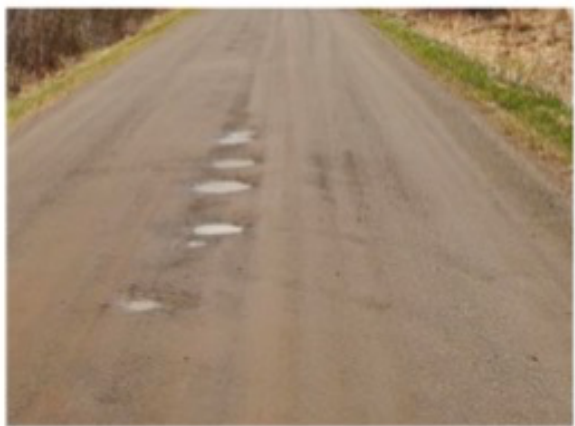
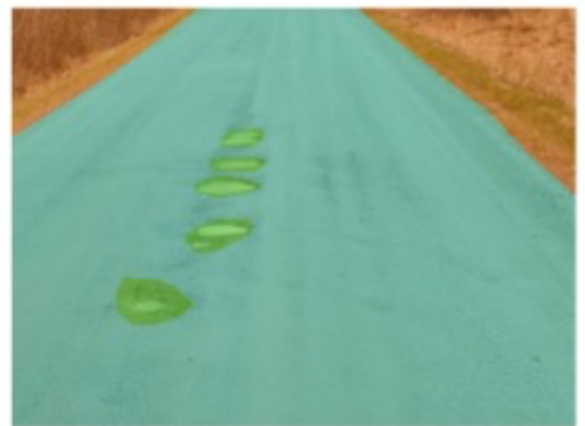
The same labelling process was applied in the testing dataset, for this dataset it was labelled one hundred and twenty-two images, as showed in Section 3.5. Figure 22 shows three samples of manually labelled images, in which the labels are overlaid on the original images.

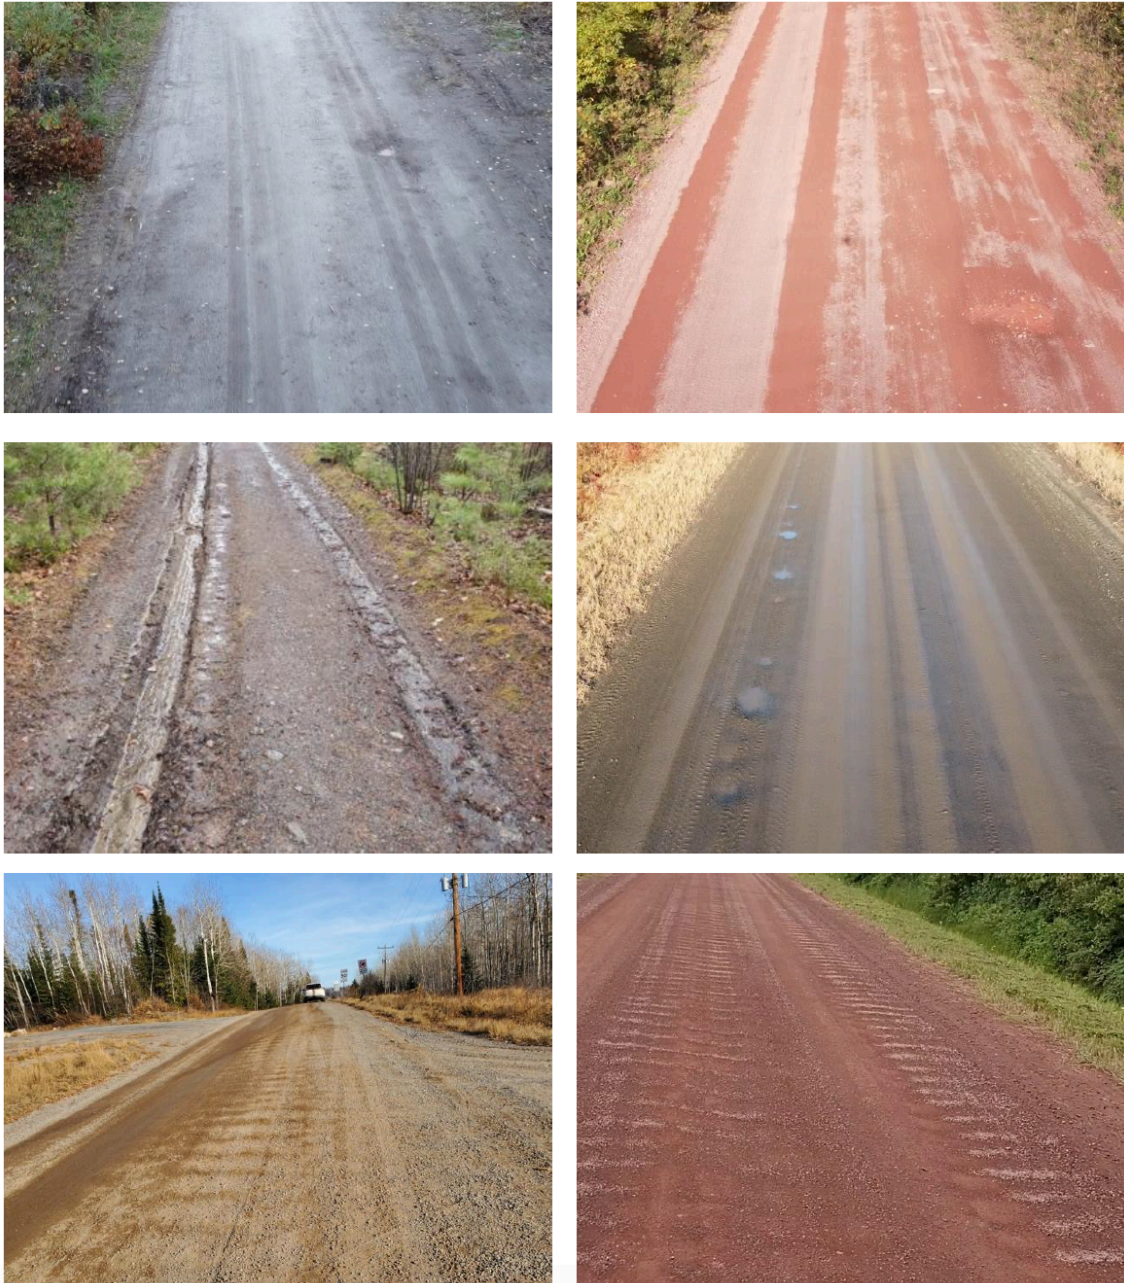
Figure 23: Sample of testing images

The trained deep neural network models were developed to assess the surface condition of different unpaved roads. A new set of images was used to perform such an assessment. These images were collected using the same procedures performed to collect the set of training images. This test dataset included one hundred and twenty-two images; a few samples are shown in Figure 23.

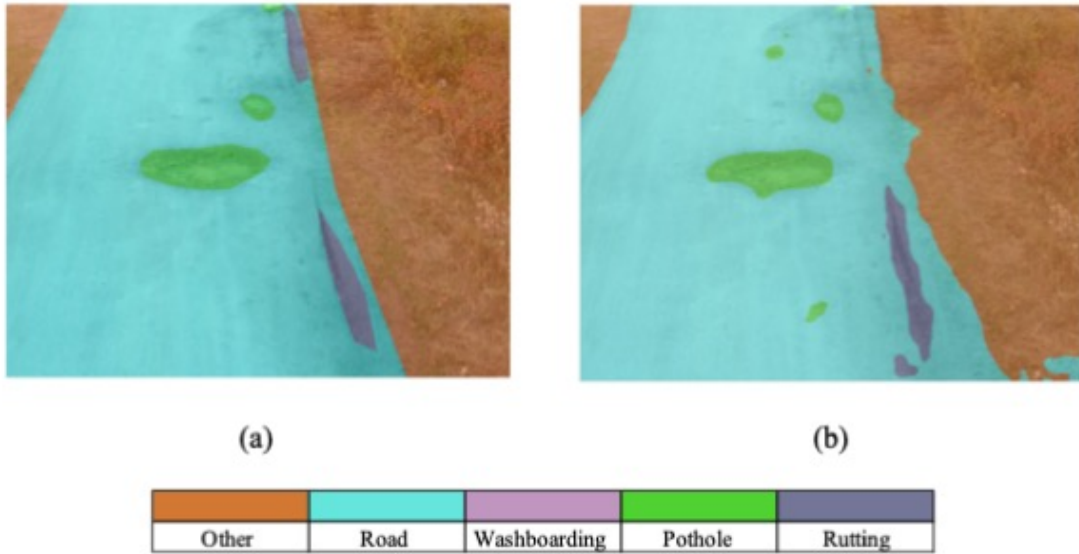
Figure 24: a) Image manually labelled; b) DCNN segmentation using mobilenetv2 trained with 700 images

Each deep neural network model (MobileNetV2, ResNet50 and Vgg16) was trained three times (560, 700 and 1000 images), providing nine different classifiers to test. The testing process was developed in two steps. First, the set of 122 images were manually labelled, using the same process described in section 3.3. However, the test images had varying sizes (e.g., 640 x 480, and 400 x 300 pixels). Then all the trained classifiers processed the test images. Figure 24 provide a sample of manually labelled image and the result of segmentation on the same frame.

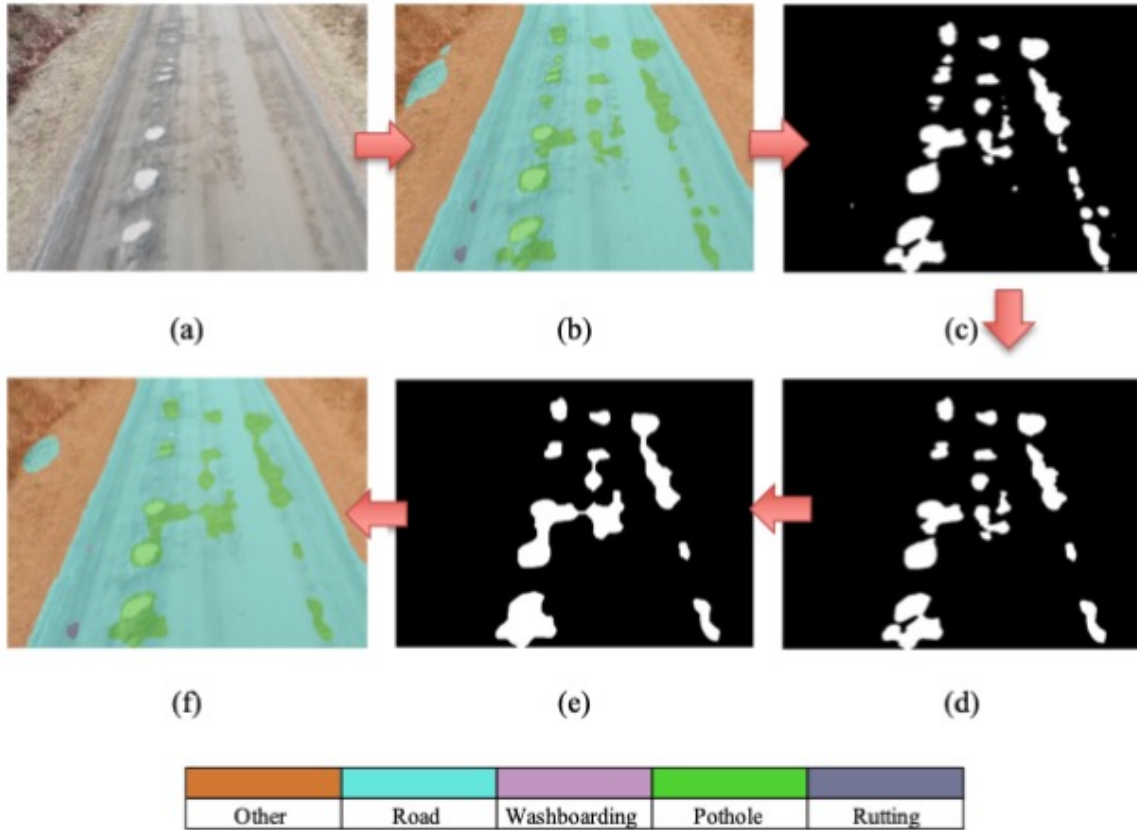
Figure 26: a) raw image; b) overlaid segmented image; c) binary mask of the pothole class; d) mask after morphological opening; e) mask after morphological closing; f) segmentation after postprocessing

An example of the proposed methodology is shown in Figure 26, in which Figure 26 .b shows the initial segmentation result, and Figure 26 .c shows the binary mask of the pothole class. As it can be seen in Figure 26 .d, many small patches are removed by the morphological opening, and adjacent remaining particles are connected in Figure 26. e. Figure 26. f shows the image with the postprocessed segmentation result.

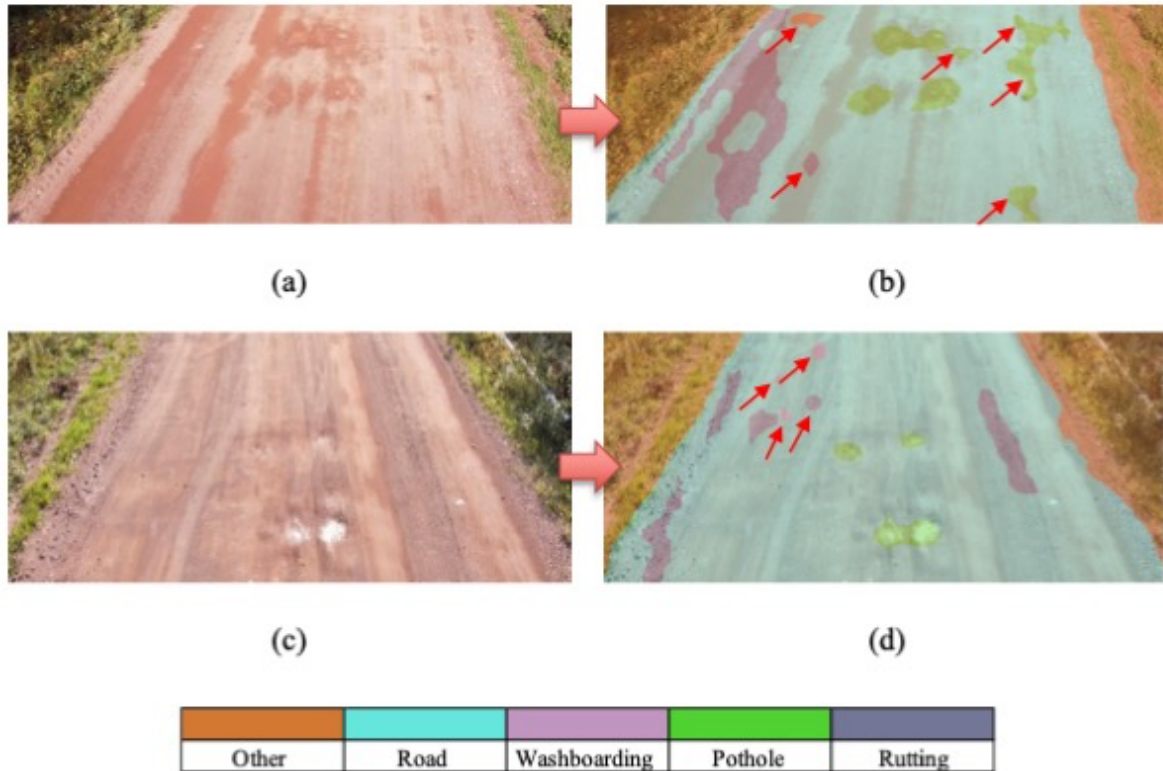
Figure 27: Road surface segmented with DCNN using Mobilenetv2_1000 for the same pothole: a) raw image obtained flying in the same direction of light; b) DCNN segmentation of image “a”; c) raw image obtained flying against the light; d) DCNN segmentation of image “c”

The false-positive instances can often be the result of light variations on the image and vegetation shades on the road surface, as shown in Figure 27, where the red arrows indicate false positives.

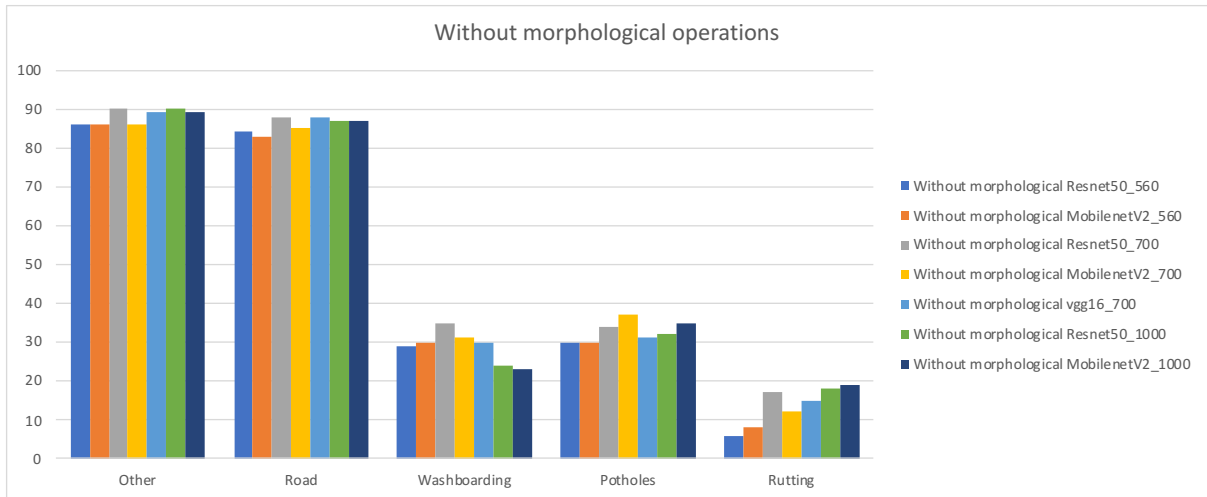
Figure 31: iou DCNN distress detection without morphological operations

Without morphological						
classes	Resnet50_560	MobilenetV2_560	Resnet50_700	MobilenetV2_700	vgg16_700	Resnet50_1000	MobilenetV2_1000
Other	86	86	90	86	89	90	89
Road	84	83	88	85	88	87	87
Washboarding	29	30	35	31	30	24	23
Potholes	30	30	34	37	31	32	35
Rutting	6	8	17	12	15	18	19

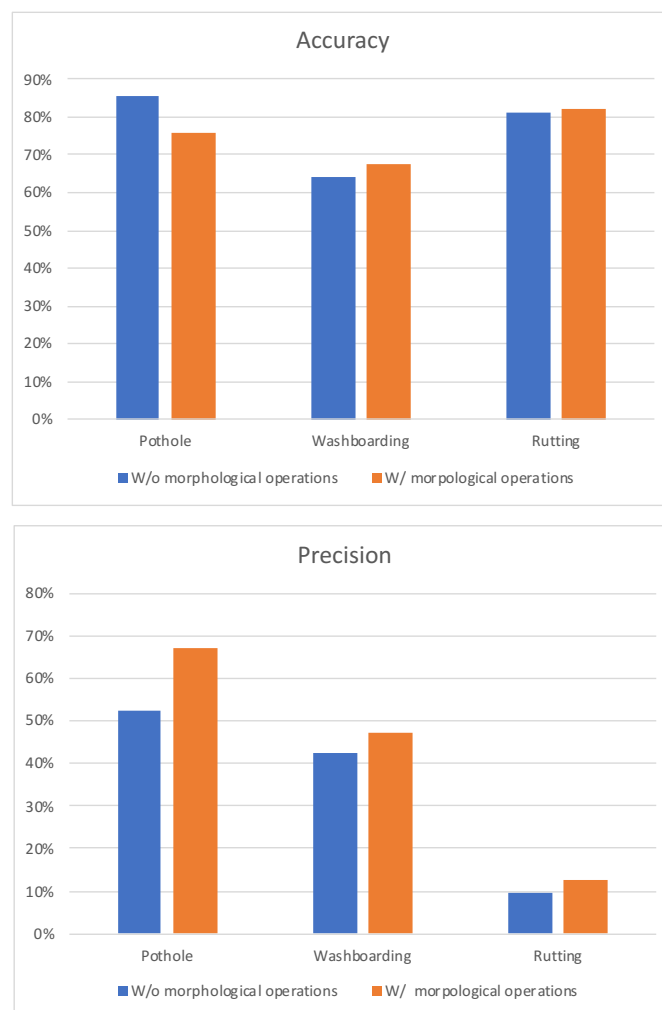
Figure 33: DCNN accuracy and precision for object level distress detection

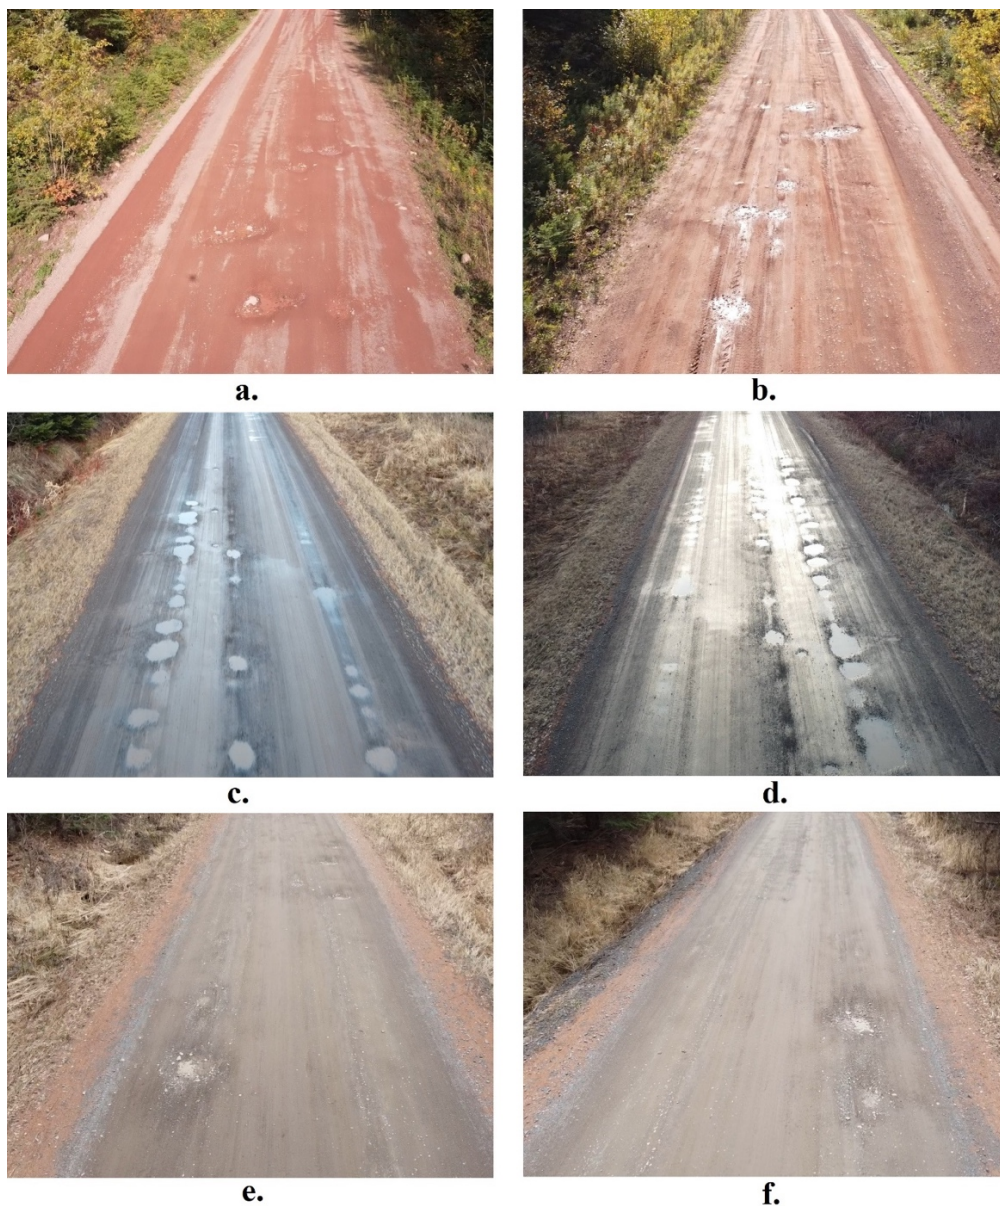
Figure 35: UAV-captured frames of same road segments from opposite directions

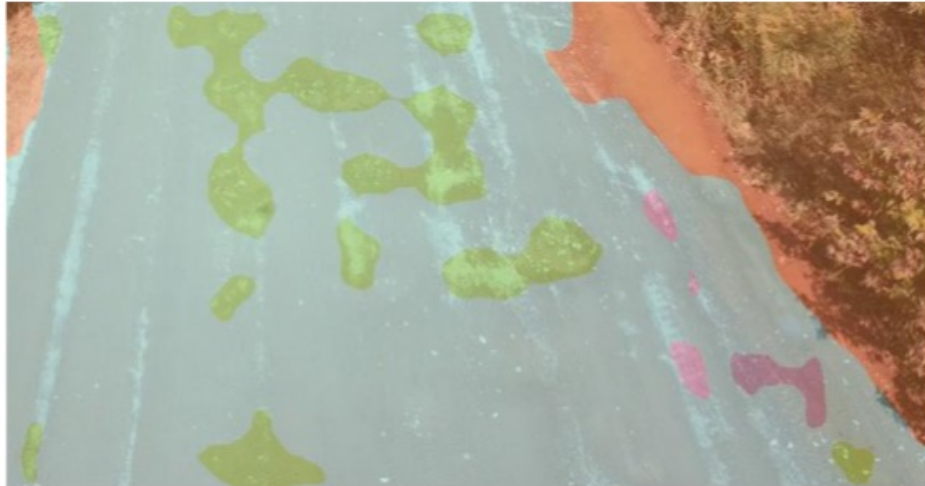
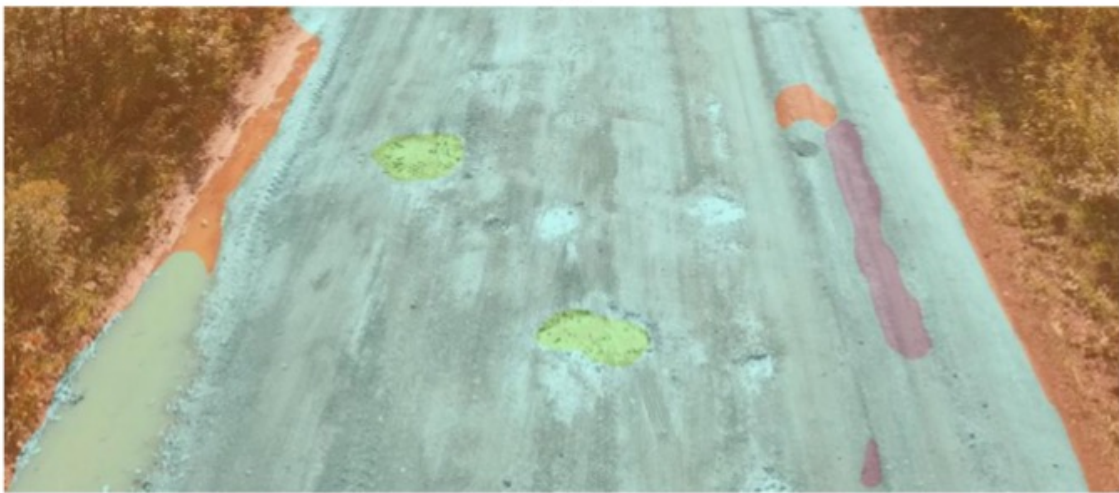
Figure 36: DCNN defect recognition. a) UAV flown towards the light; b) UAV flown against the light

To develop such comparison, three different unpaved road sections were selected in sunny days and the drone was flown on the same part of the road in opposite directions: one flying towards the light and the second flying against the light. The videos were processed as described in Section 3.2 Data preparation process, where the frames were acquired to be later visually compared and matched, similar to samples presented in Figure 35.

The Mobilenetv2 DCNN model trained with 700 images were used to recognize the defects on the six sets of images. A sample result of segmentations on a corresponding set of frames can be seen in Figure 36.

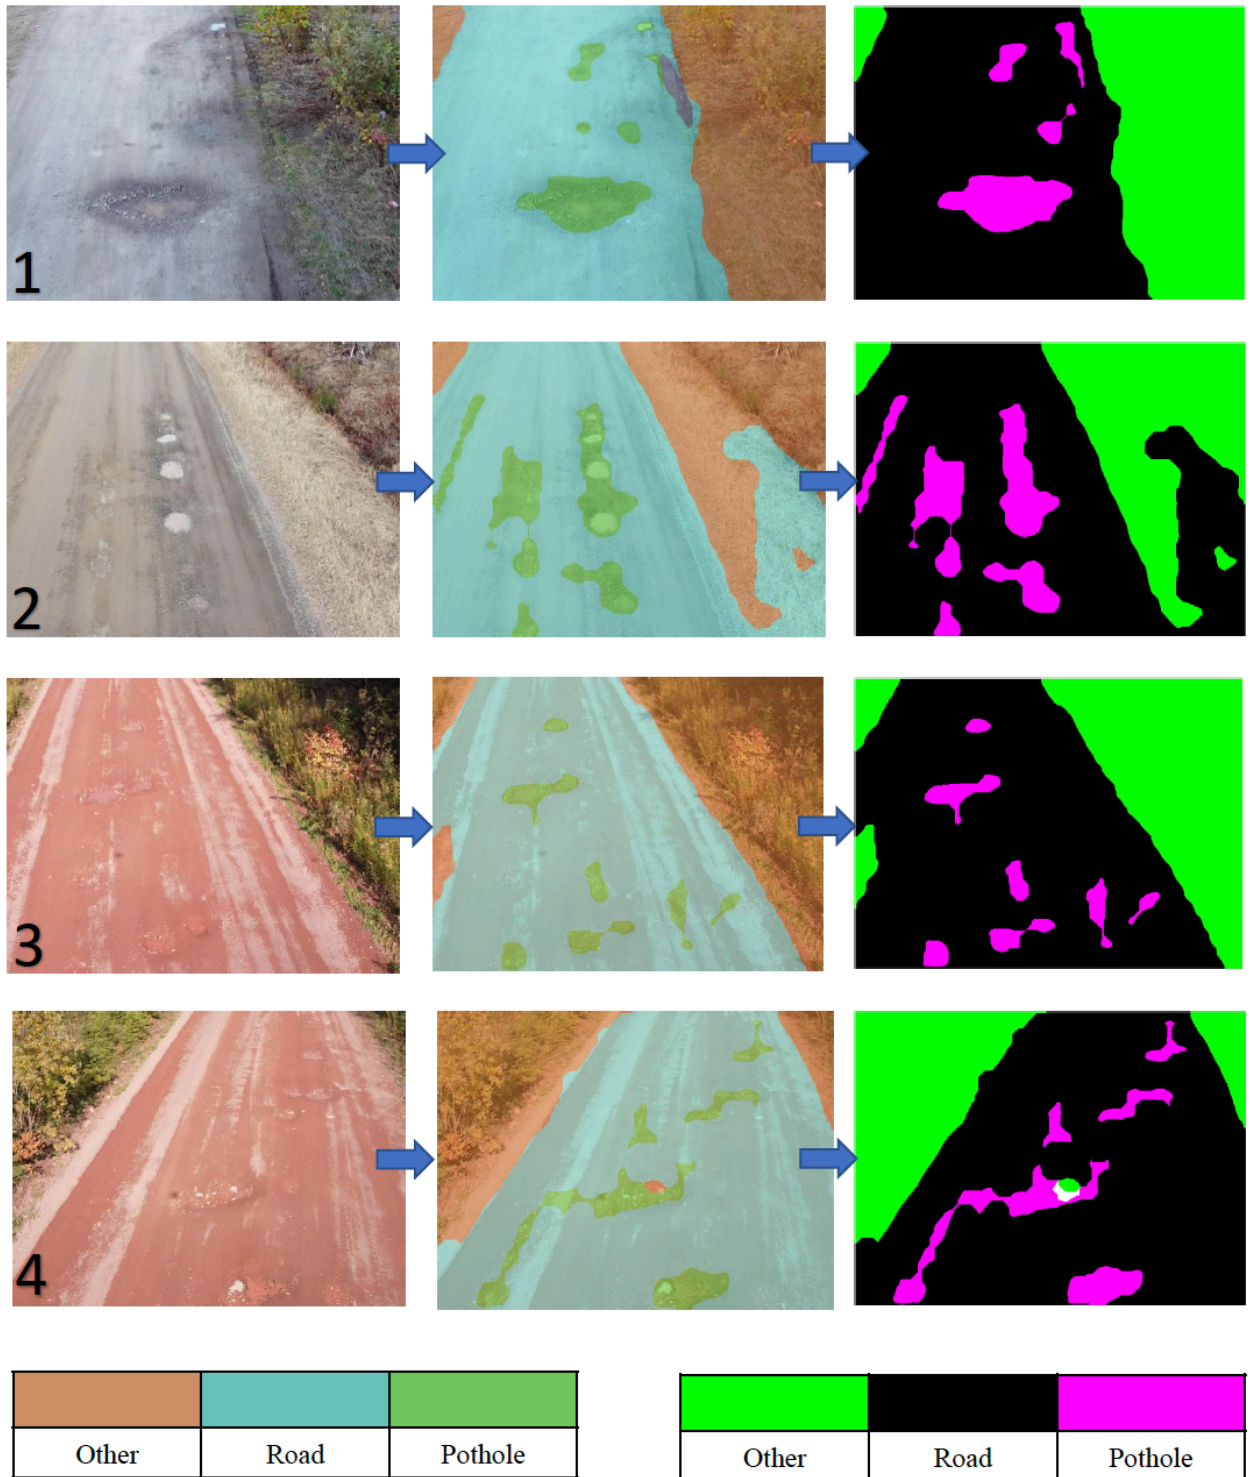
Figure 37: Pothole distribution on four distinct samples from the test dataset

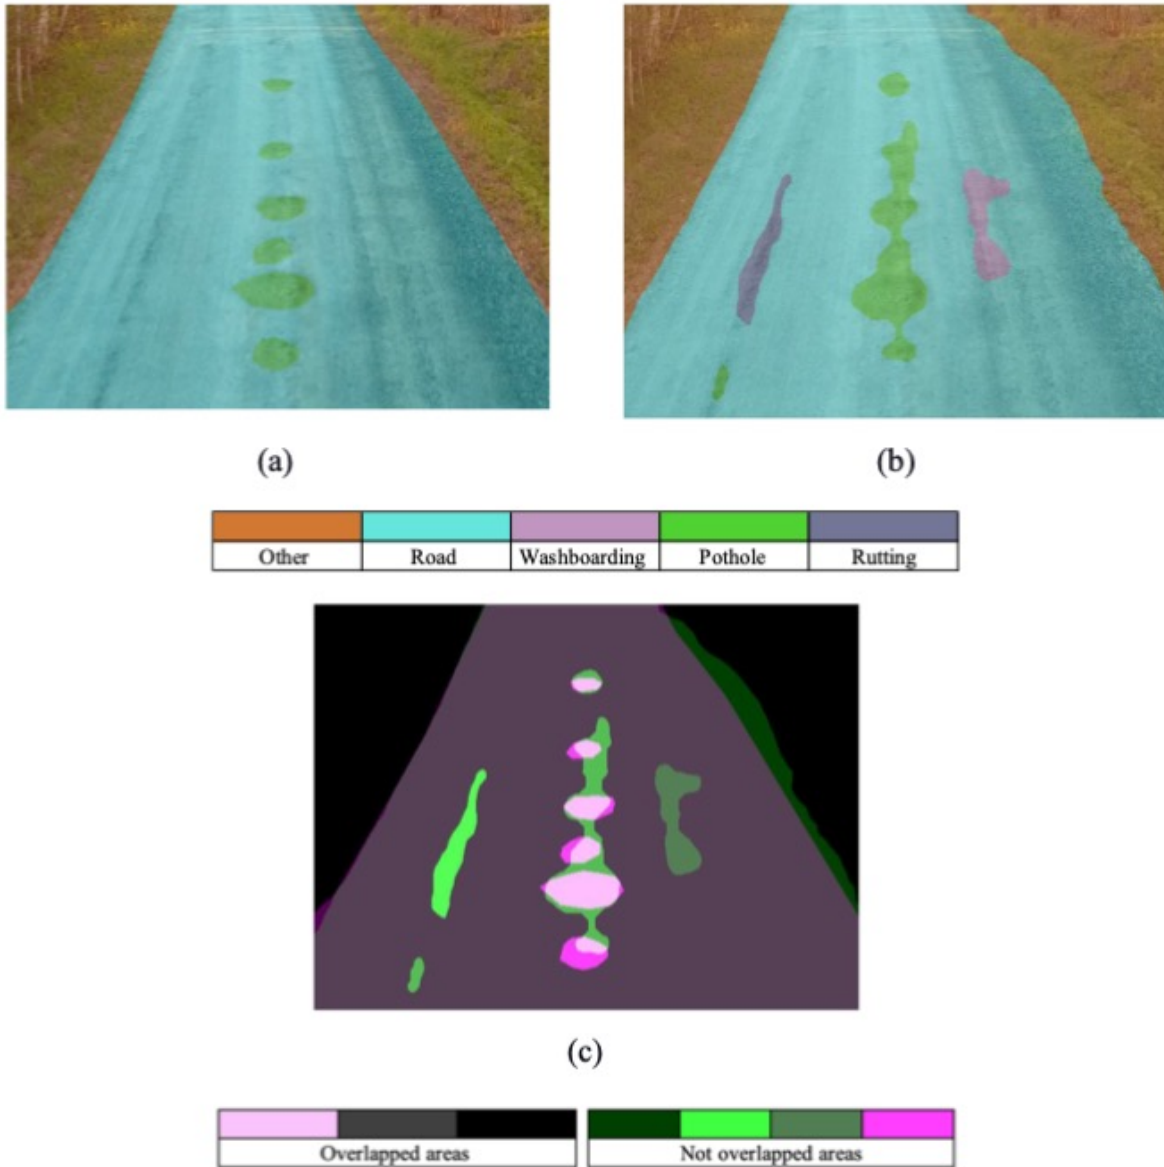
Figure 38: Intersection over union: a) Manually labelled image; b) DCNN-based (mobilenetv2, trained with 1000 images) defect segmentation; c) overlapped areas
